# Trip A-3

## THE 1993 LEMIEUX LANDSLIDE AND MER BLEUE BOG, SOUTHEASTERN ONTARIO, CANADA

### SECTION 1. THE LEMIEUX LANDSLIDE

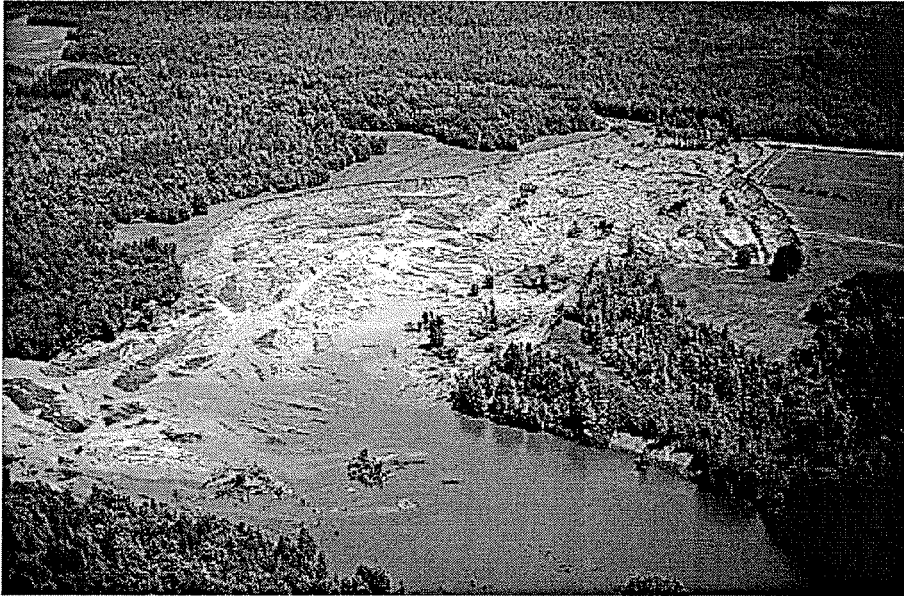
Figure 8. The Lemieux landslide several days after failure. Note the large intact rafted sections, and the severing of Regional Road 16. Some of the rafted blocks show rotation while the bedding in other blocks remains horizontal suggestive of lateral translation. The blocked South Nation River, flowing from right to left, is at the bottom of the picture. Photograph from the Geological Survey of Canada.

Late on the afternoon of June 20, 1993, a 17 ha area of sensitive marine silt and clay close to the Lemieux townsite failed with flow proceeding rapidly into the South Nation River (Figure 8). The first eyewitnesses noted a water displacement of up to 2 m high moving along the river both up- and downstream. Trees and spoil accumulation were soon noted at the bridge crossing Regional Road 8. It took over half an hour for the retrogressive failure to reach and sever Regional Road 16, with portions of the road surface being rafted up to 200 m down into the crater. One motorist on Regional Road 16 ended up in the crater, and was rescued by a Canadian Forces helicopter. In all, Brooks *et al.* (1994) estimate that the entire failure event probably lasted less than one hour. The debris from the landslide eventually buried 3.3 km of valley bottom and caused flooding 18 km upstream. Costs relating to the failure event have been estimated at \$12.5 million Canadian dollars.

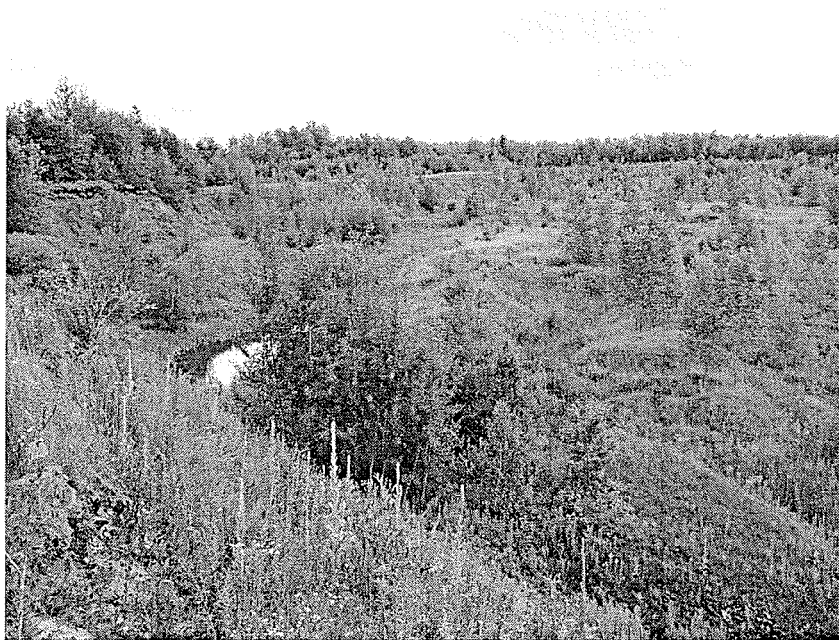
Figure 11. The Lemieux landslide crater in 2004, 11 years after the failure. Total crater depth is approximately 10-12 m. Notice the muting of the previously sharp-edged blocks of cap material. Revegetation of the crater is also well underway.

In walking through the bowl eleven years after the event, it is obvious that previously sharp-edged blocks and topography have been muted through ongoing erosion (Figure 11). Several of the ridges contain trees that survived the rafting event, while the general vegetation is of more recent succession. Several sections of impounded drainage contain cattails.

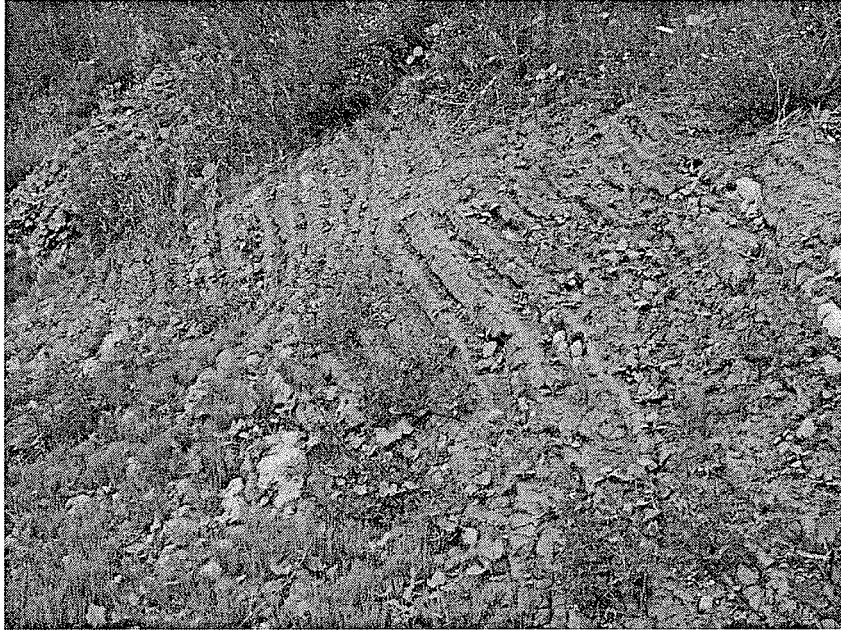
Figure 12. Rhythmic bedding of silt and clay on the banks of the South Nation River.

The failure occurred at depths of greater than 10 m (Evans and Brooks, 1994), so the majority of the surficial material in the failure bowl is reworked sand that provided the stiff cap sediments. Transported Leda clay is not noticed until the banks of the South Nation River are reached (Figure 12). Tilted rhythmic bedding is noticed on both banks of the river. Groundwater piping at the edge of the crater, noted shortly after failure (Aylsworth *et al.*, 1997), is no longer visible. The river has entrenched 5-6 m into the spoil pile and river flow has essentially been restored (Aylsworth *et al.*, 1997), with striated limestone bedrock exposed to the north of the failure.

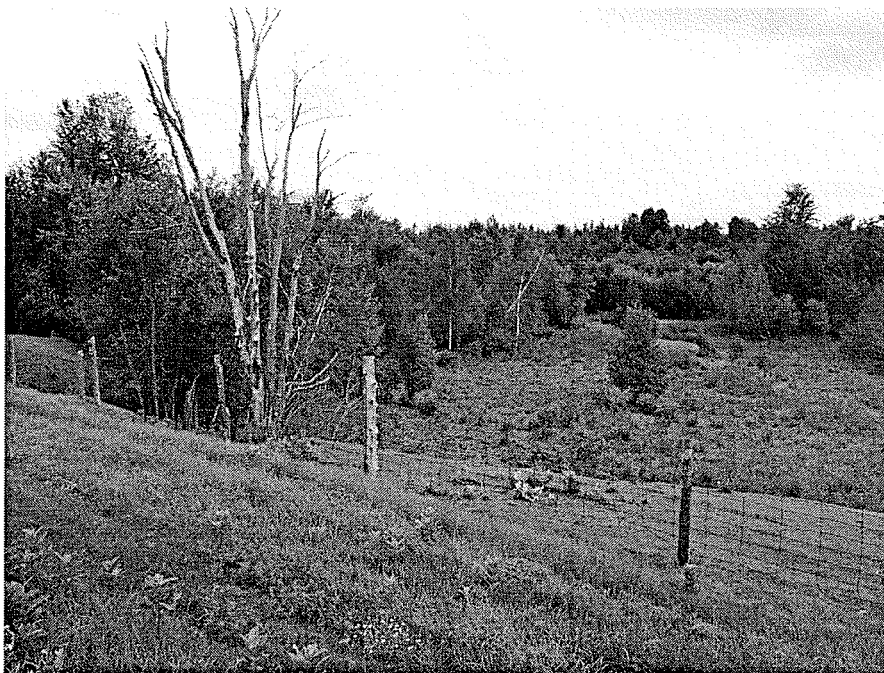
Figure 14. The headwall scar of the 1895 landslide.

This brief stop is at the headwall of the 1895 landslide (Figure 14) that covered 24.4 ha and retrogressed a total of 600 m from the South Nation River. Notice that the landslide scar is now well vegetated and is used by the owner as a pasture.

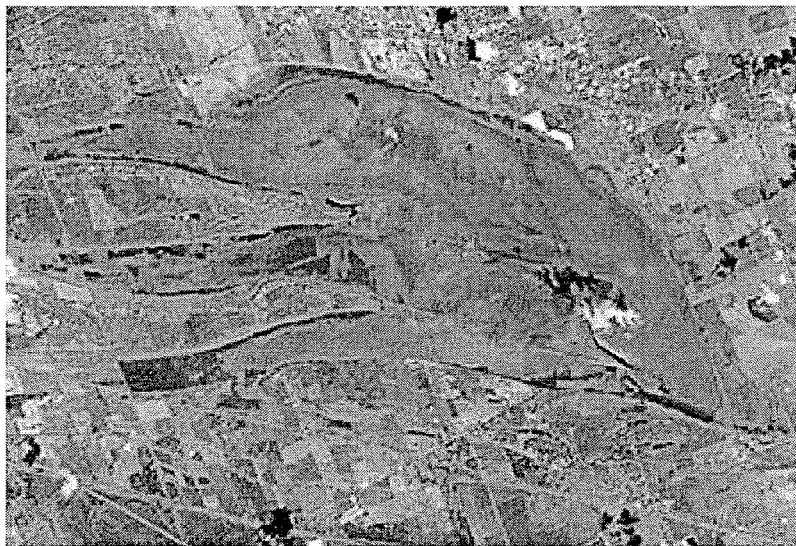
Figure 15. A satellite image of Mer Bleue surrounded by farmland. Sand ridges formed by the paleo Ottawa River produce a digitate nature to the western portion of the wetland.

Mer Bleue Bog is a Provincial Conservation Area in the eastern portion of the National Capital Region, and less than 10 km from the city of Ottawa. The bog covers approximately 3500 hectares (Figure 15), and has formed in an abandoned channel of the Ottawa River. The western section of the bog has three distinct arms, separated by sand ridges that were formed by the anastomosing river channel.

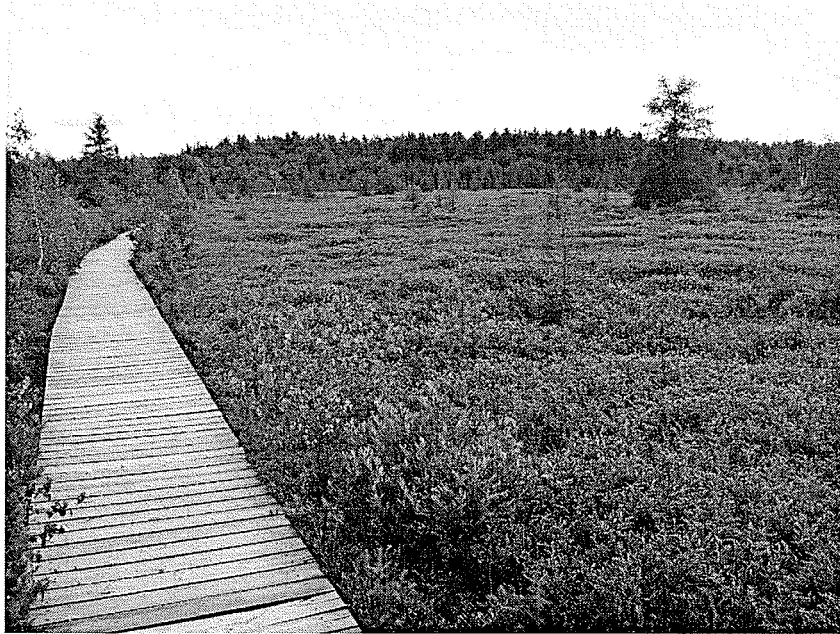
Figure 16. The raised, central portion of Mer Bleue.

The majority of the central portions (Figure 16) of the bog are composed of a raised carpet of *Sphagnum* mosses, representing an ecological community usually found further north in the boreal forest of Canada. Other vegetation dominating the raised central portions includes Labrador tea (*Ledum groenlandicum*), bog laurel (*Kalmia polifolia*), Leatherleaf (*Chamaedaphne calyculata*), and various sedges. The majority of trees in the central portions are tamarack (*Larix laricina*), with some black spruce (*Picea mariana*) in more acidic areas. The dominance of *Sphagnum* species and a lack of contact with mineralized groundwater leads to acidic conditions within the bog.

Raised bogs such as Mer Bleue obtain all of their nutrients through rainwater, and are termed ombrotrophic peatlands. Drainage from the raised portions flows laterally to the marginal channels. These channels, or lagg areas, provide the slow continual lateral drainage for the central portions of the peatland. Marginal areas of the bog are actually marsh (Figure 17), composed of open water lagg and vegetated primarily by cattails (*Typha sp.*), *Salix sp.*, and various sedges. Drainage of the wetland downwards is impeded by the presence of fine-grained material, including Leda clay. Lagg areas generally have greater contact with mineralized groundwater and their less acidic waters are able to support more luxurious vegetation.

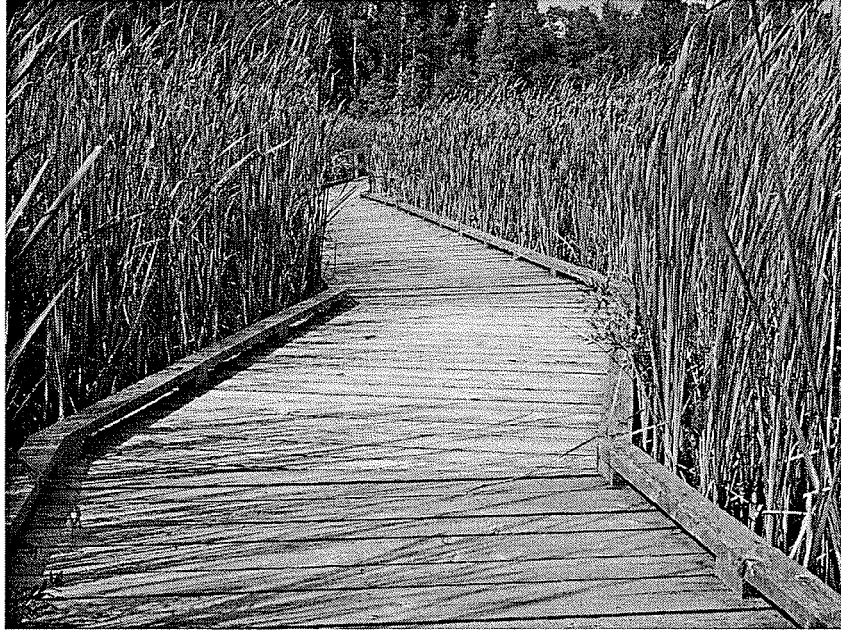
Figure 17. The marginal areas of Mer Bleue act as drainage for the central portions, and are dominated by open water and marsh vegetation, predominantly cattails.
